November 8, 2018

Project Number 1180828C

Subject: EZ 1" Mini Standing Seam Clamp with L-Foot Laboratory Load Testing
Part #K50200-002 Attached to 24ga EZ Lock by Taylor Systems

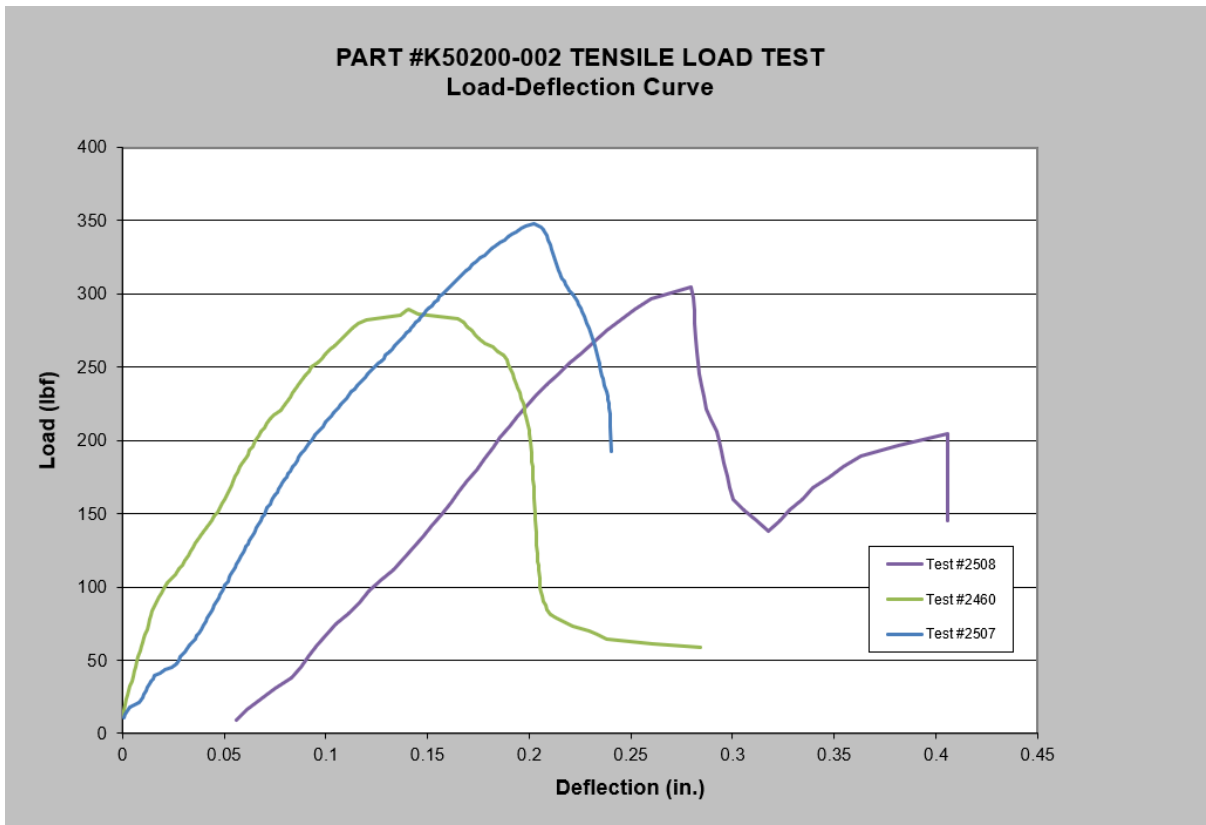
FIGURE 1

Based on the above testing, the average maximum uplift load of the EZ 1" Mini Standing Seam Clamp with L-Foot attached to a 24ga EZ Lock roofing sample by Taylor Systems was determined to be 314 lbf. Detailed results are provided in Table I and Figure 1. Test setup and mode of failure are provided in Appendix B, Figure B1.

A total of three tests were conducted for tensile (uplift) load capacity on October 22, 2018 using a United Universal testing machine. Samples were rigidly attached to the testing machine and an uplift (tensile) load was applied to each clamp. The samples were loaded in tension at a constant rate of axial deformation of 0.10 in. /min. without shock until failure occurred; deflection at maximum load was recorded.

TEST NUMBER	MAXIMUM TENSILE LOAD (lbf)	DEFLECTION AT MAXIMUM LOAD (in.)	MODE OF FAILURE
2460	290	0.1	Seam Clamp Slippage
2507	348	0.2	
2508	304	0.3	
AVERAGE	314	0.2	..

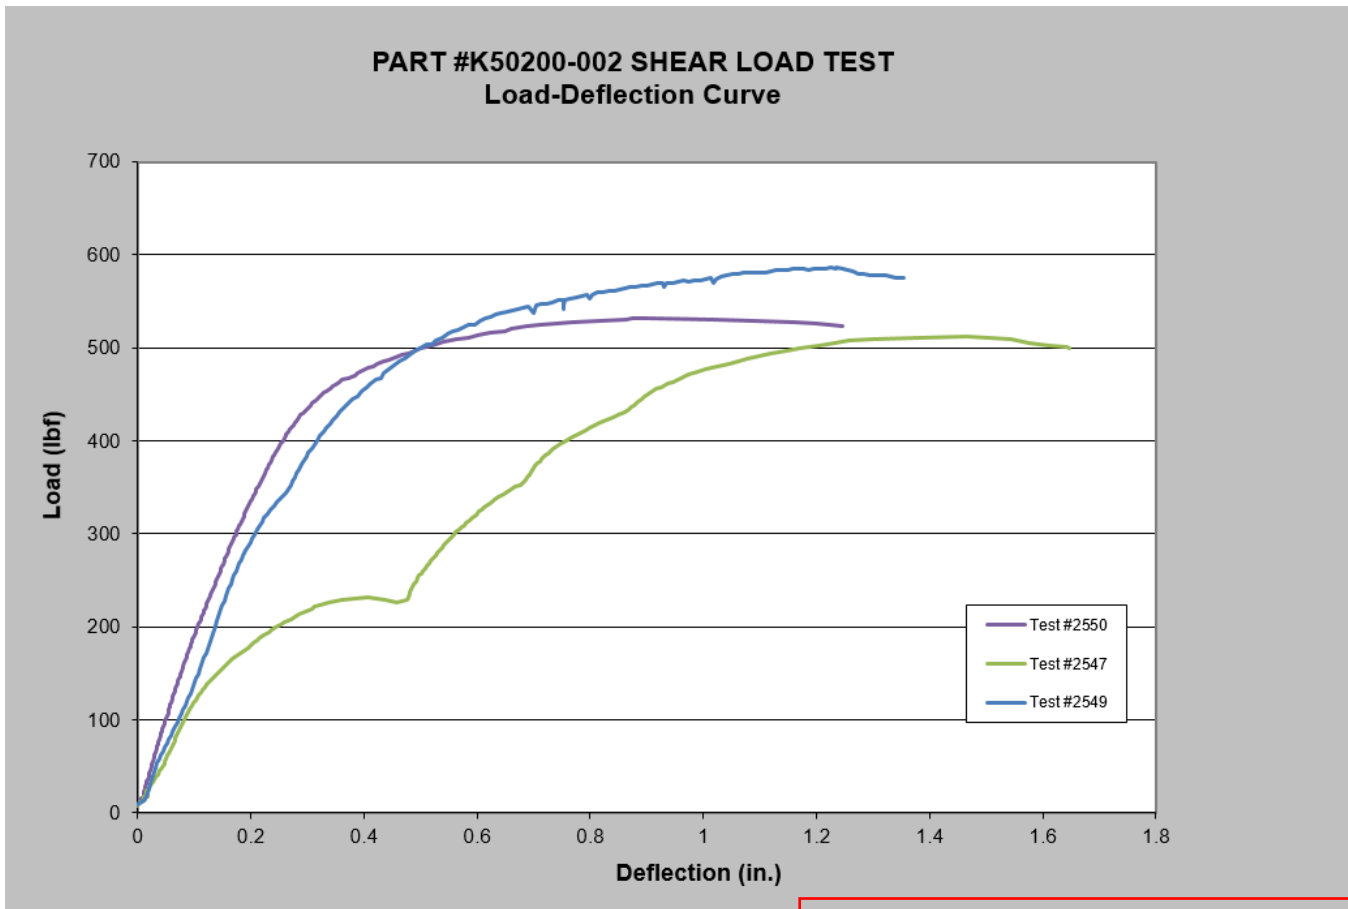
FIGURE 2

Based on the above testing, the average maximum shear load of the EZ 1" Mini Standing Seam Clamp with L-Foot attached to a 24Ga EZ Lock roofing sample by Taylor Systems was determined to be 544 lbf. Detailed results are provided in Table II and Figure 2. Test setup and mode of failure are provided in Appendix B, Figure B2.

A total of three tests were conducted for lateral (shear) load capacity on October 25, 2018 using a United Universal testing machine. Samples were rigidly attached to the testing machine and a shear load (parallel to the rafter and roofing sample seam) was applied to each clamp. The samples were loaded in a downward direction at a constant rate of axial deformation of 0.10 in. /min. without shock until failure occurred; displacement at maximum load was recorded.

TEST NUMBER	MAXIMUM SHEAR LOAD (lbf)	DEFLECTION AT MAXIMUM LOAD (in.)	MODE OF FAILURE
2547	512	1.4	Seam Clamp Slippage
2549	586	1.2	
2550	533	0.9	
AVERAGE	544	1.2	..

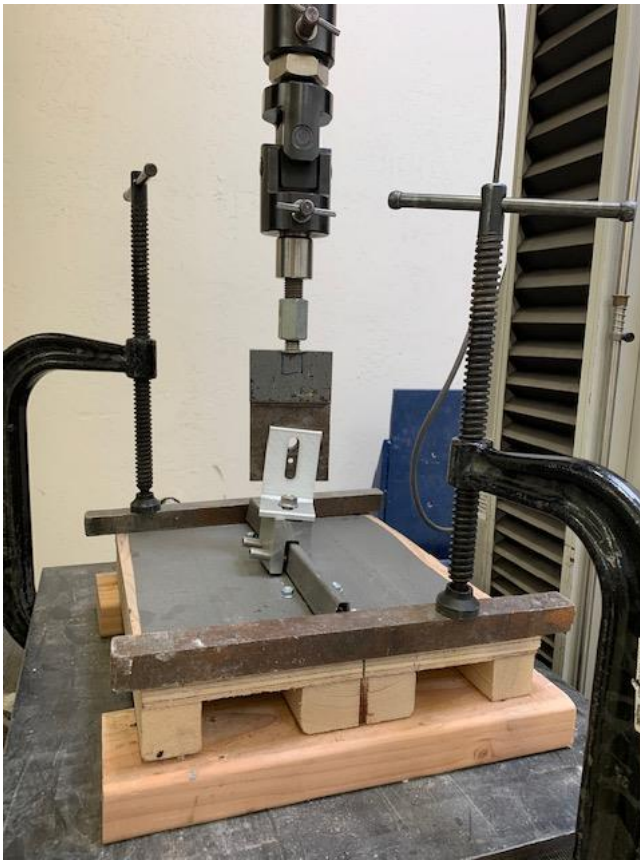
Figure B1a. Test Setup

TENSILE LOAD TEST SETUP

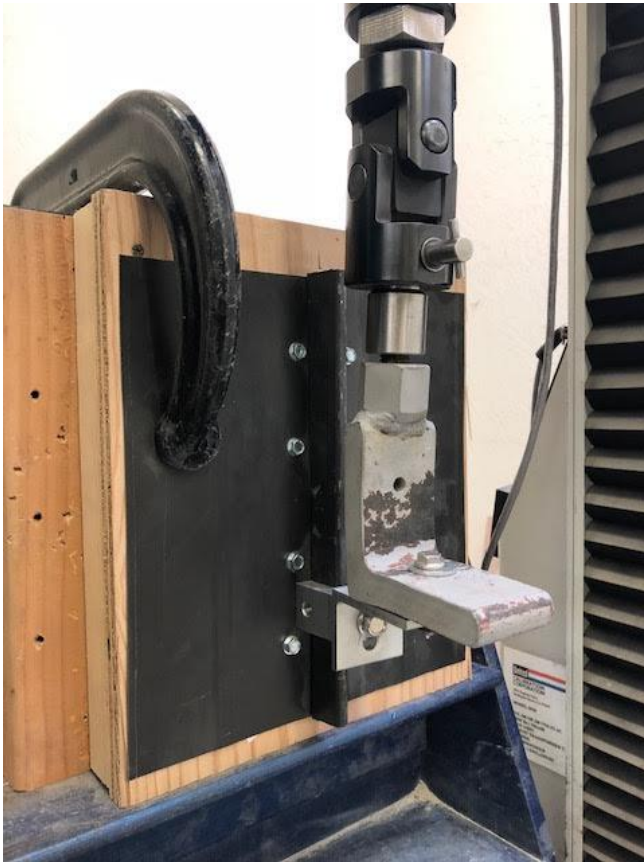
Figure B2a. Test Setup

LATERAL (SHEAR) LOAD TEST SETUP
